CAMPBELLS LEDGE DAM

NDI ID NO. PA-00649

PHASE I INSPECTION REPORT
NATIONAL DAM INSPECTION PROGRAM

411 004
JANUARY 1979

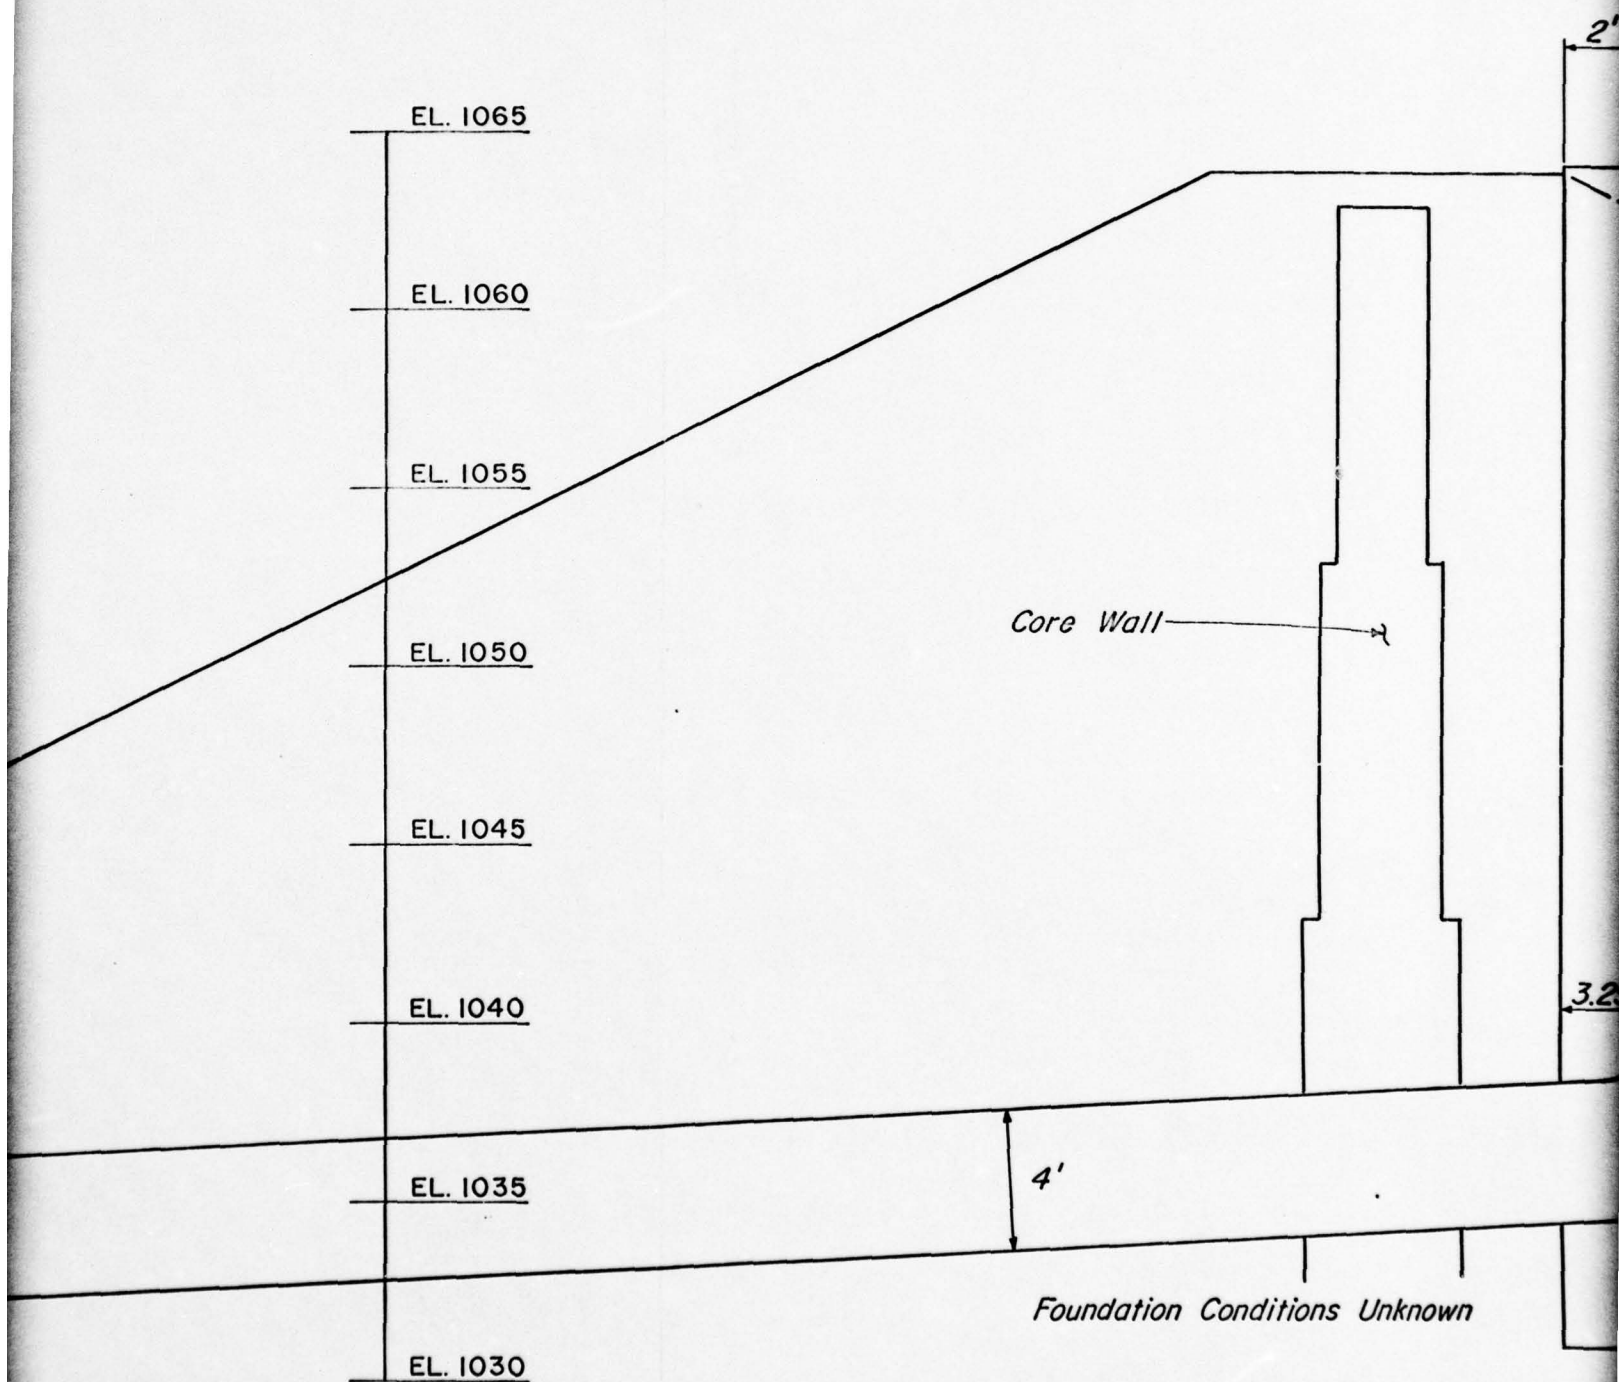
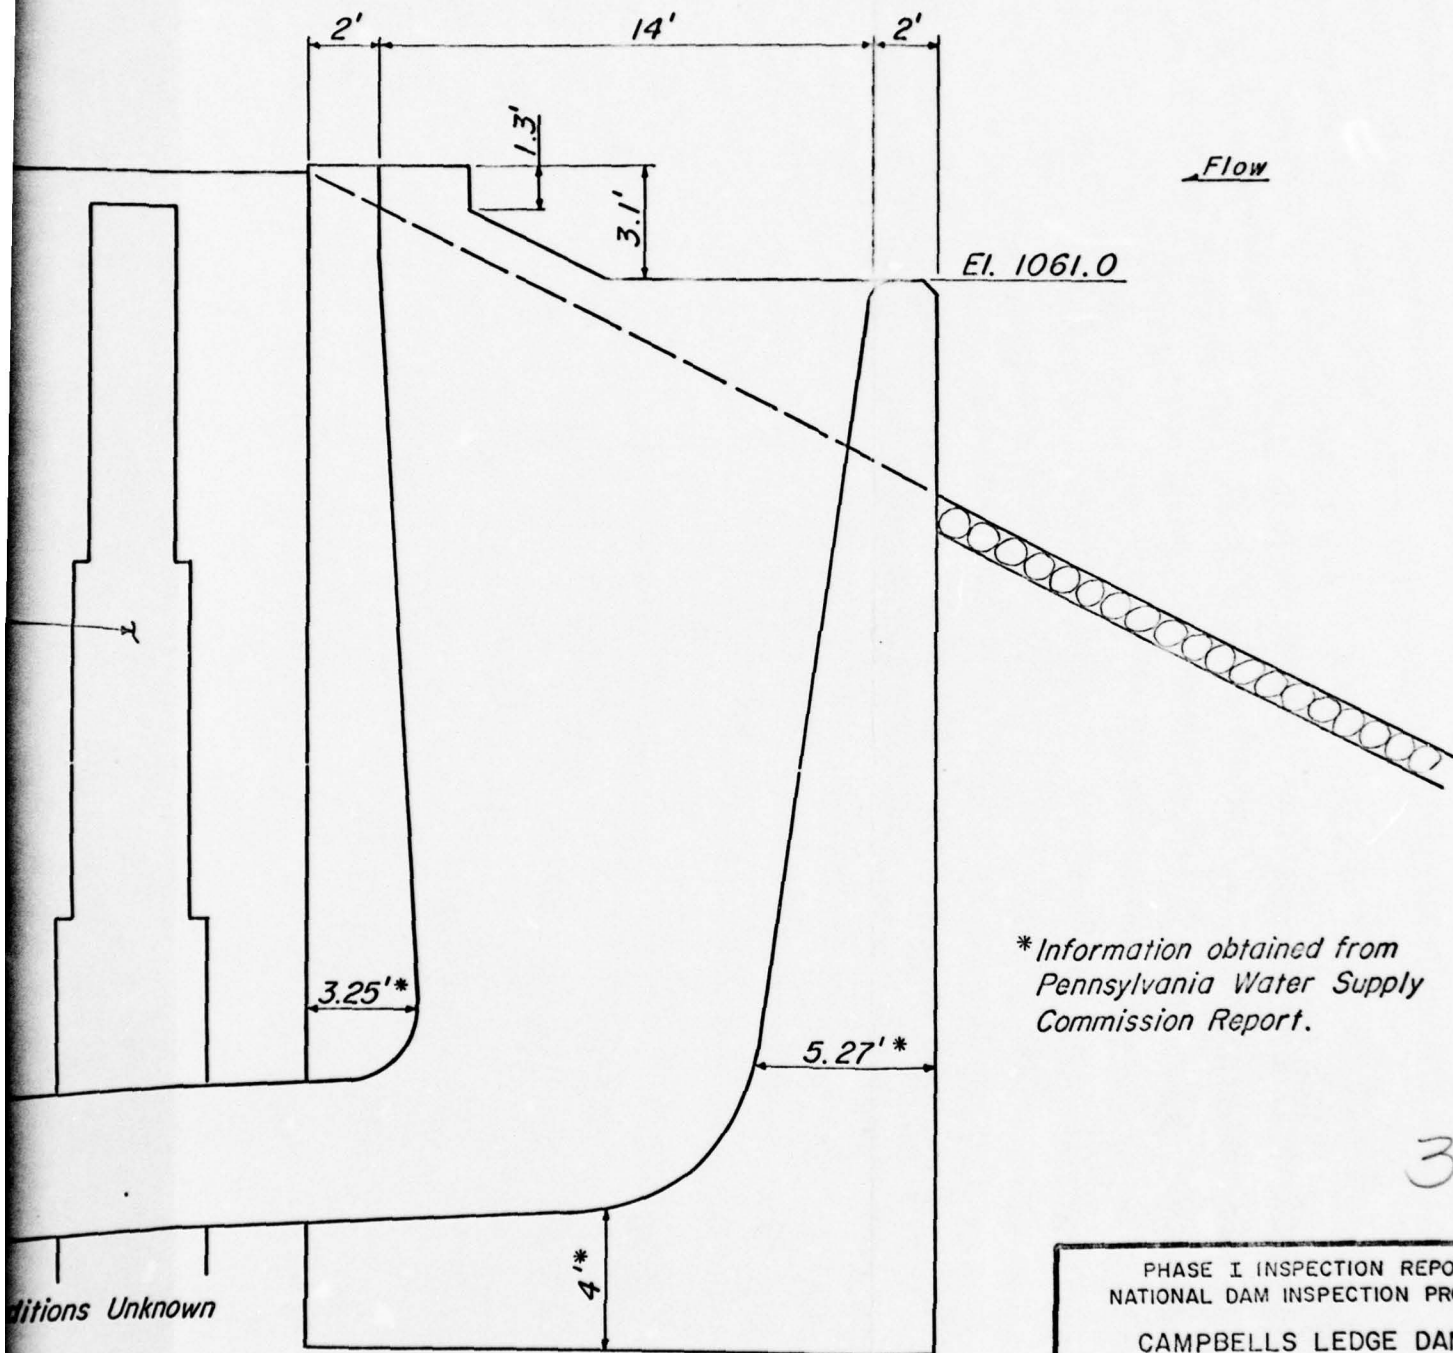
(3) Appurtenant Structures. The conditions at the spillway are of concern. Plate 4 shows the structural dimensions of the spillway, as determined from the field inspection and from the 1914 Pennsylvania Water Supply Commission Report. The spalling is sufficiently severe in the vertical shaft that the integrity of the structure may be threatened if spalling continues. The embankment exerts earth pressure around the entire vertical shaft. There is also full hydrostatic loading. The seepage observed indicates that a piping potential may exist, although no evidence of piping was observed.

VISUAL EXAMINATION OF	OBSERVATIONS	REMARKS OR RECOMMENDATIONS
CONCRETE WEIR	RECENTLY REPAIRED MAJOR SPALLING FROM 6' BELOW CREST. IRON FENCE AROUND CREST.	SEE PLATE 4 SEEPAGE THROUGH DETERIORATED CONCRETE.
APPROACH CHANNEL	RESERVOIR	
DISCHARGE CHANNEL	SEE NEXT SHEET	
BRIDGE AND PIERS	NONE

(1) Perform additional hydraulic and structural design studies to determine the best method of repairing the spillway vertical shaft and conduit without decreasing the spillway capacity. The study should also address both the necessary repairs to the stilling basin and the suitability of removing the iron fence around the spillway. To increase the spillway capacity, the embankment should be raised to its design elevation.

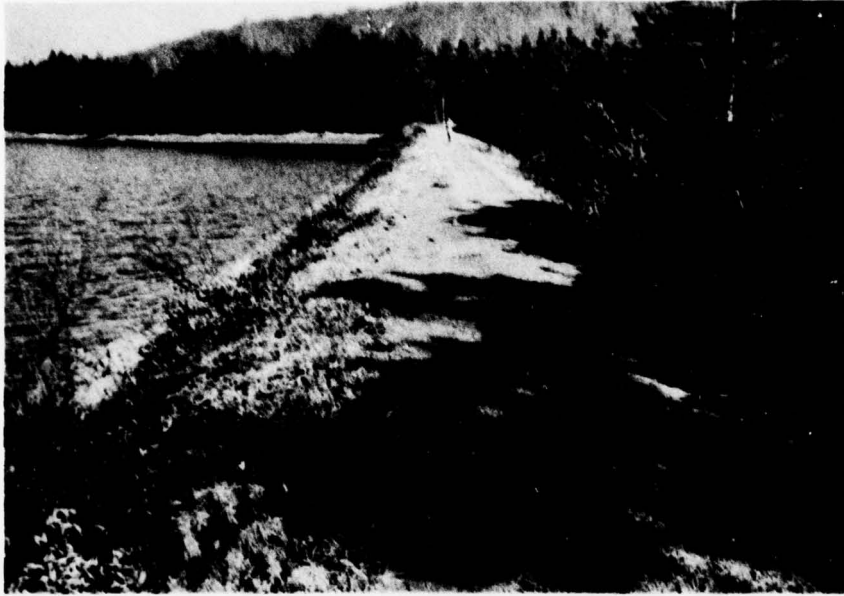
b. Embankment. The South Embankment appears in good condition. The entire top of the embankment is at or above the design elevation as noted in Appendix B. Tire ruts, approximately 4 inches deep, were noted along the top of the embankment. No seepage or wet areas were observed on or downstream of the embankment. There is minor bulging of the riprap on the upstream slope about 4 feet below top of dam. There is a sparse cover of brush, about 1 inch in diameter, on the embankment except at both abutments on the upstream slope, where the brush is up to 2 inches in diameter and much thicker (Photograph A). Mature trees are growing at the toe of slope to the right of the outlet works.

(2) Embankment. Tire ruts on the top of dam, if not repaired, can result in a lower elevation of the top of dam. Brush and trees on the embankment and at the toe are undesirable. The bulging of the riprap is probably caused by uneven grading during construction. The low area on the North Embankment is probably caused by uneven grading during construction, although a slight settlement of the embankment may have occurred. The wet area downstream of the North Embankment is not of major concern, as no seepage or standing water was observed.

A. South Embankment - View from Right Abutment.

(4) Monitor bulges at the upstream slope of the South Embankment. If changes are noted, an evaluation of the embankment stability should be made.

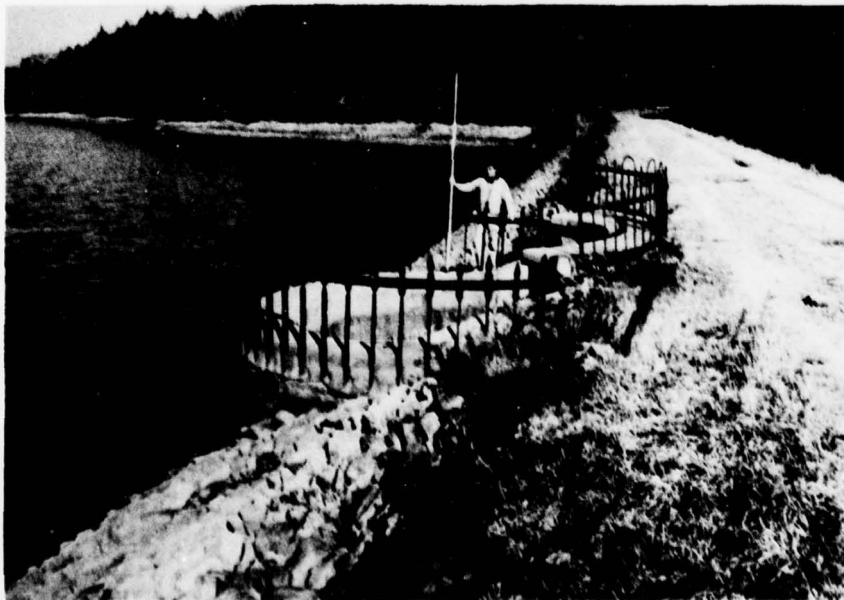
The spillway is in fair condition. An iron fence surrounds the spillway (Photograph B). The upper 6 feet of the Morning Glory shaft appears to have been repaired previously and the concrete appears to be in good condition. Below this elevation, the concrete is severely scoured and spalled over most of the vertical shaft. A maximum spall depth of 0.5 foot was estimated, but the area was inaccessible for exact measurements. A small pipe, the purpose of which is unknown, extends through the right wall of the vertical shaft about 6 feet below the crest. Seepage was observed from this pipe. Seepage was also observed over the face of the shaft below this elevation. The elbow juncture of the vertical shaft and the horizontal conduit is also severely spalled. The conduit appears to have been rough-formed. The entire bottom of the conduit is severely scoured. The walls and roof of the conduit are in good condition except, at many points, the reinforcing bars are exposed. These bars are severely rusting and deteriorated. It appears that little concrete cover was provided for these bars during construction.

B. Spillway.

The fence around the spillway has a potential of collecting debris. The various inspections by the Commonwealth note the fence but do not consider it a hazard. It acts as a personnel safety feature. Removing the fence around the lower part of the crest and providing a floating trash boom would reduce the debris collection potential. Because of the scour observed on the floor of the conduit and in the stilling basin, the potential of scour threatening the structures appears high. The scour is probably due to cavitation effects of flow through a morning glory spillway of unusual design.

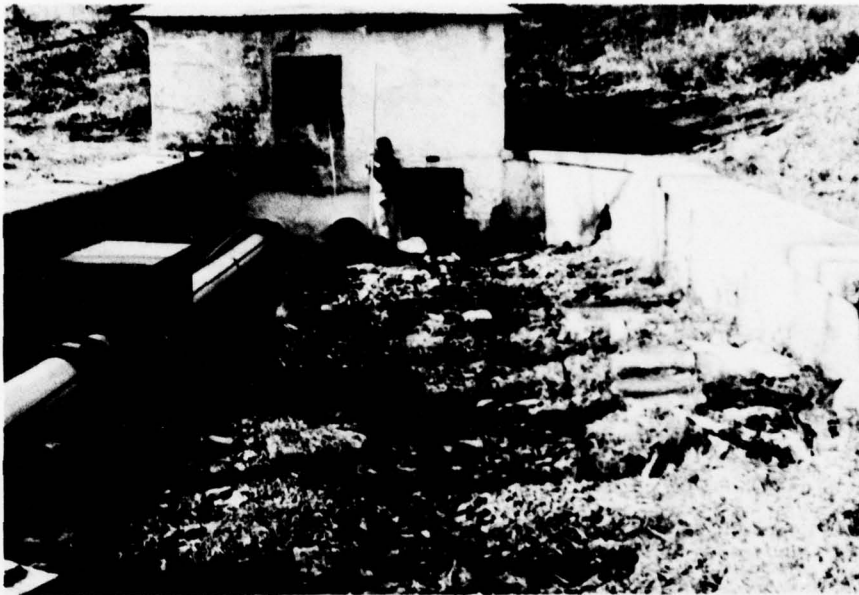
The spillway and emergency drawdown line discharge jointly into a stilling basin (Photographs C and D). The concrete bottom of this basin is almost completely scoured. The left wall of the basin has a shrinkage crack about 15 feet beyond the outlet works and another at the curved section of wall near the outlet works. There is spalling evident at the latter crack. At the right wall, there is a crack

about 15 feet downstream of the outlet works. Upstream of this crack, the wall is tilted towards the stilling basin. The total seepage at the downstream end of the conduit was estimated at 0.5 gpm, although it appeared that a greater quantity was seeping into the throat of the spillway. Some of the seepage may have been infiltrating through the bottom of the conduit.

The conditions at the stilling basin are an indication of inadequate design and lack of maintenance. From review of the periodic inspection reports by the Commonwealth, the damage to the stilling basin appears to have occurred between 1941 and 1943. A major flood occurred in the area during 1942.

C. Spillway and Outlet Works Outlet
